Rehabilitation Management Plan for Canyonleigh Bauxite Mine PLL1236 (Act 1992)

Summary Table	
Name of Mine	Canyonleigh Bauxite Mine
RMP Commencement Date	July 2022
Mining Authorisations	PLL1236
Mining Lease Expiry	15/05/2040
Name of Authorisation Holder	PGH Bricks & Pavers Pty Ltd
Name of Mine Operator (s)	PGH Bricks & Pavers Pty Ltd
Name and Contact Details of the Mine Manager	Joe Gauci (02) 9826 9964 jgauci@csr.com.au
Name and Contact Details of the Environmental Representative	Melanie Windust 0450 392 709 mwindust@csr.com.au
Name of the Representative of the Authorisation Holder	Joe Gauci
Signature of the Representative of the Authorisation Holder	15 Cami
Date of Submission	12/12/2022

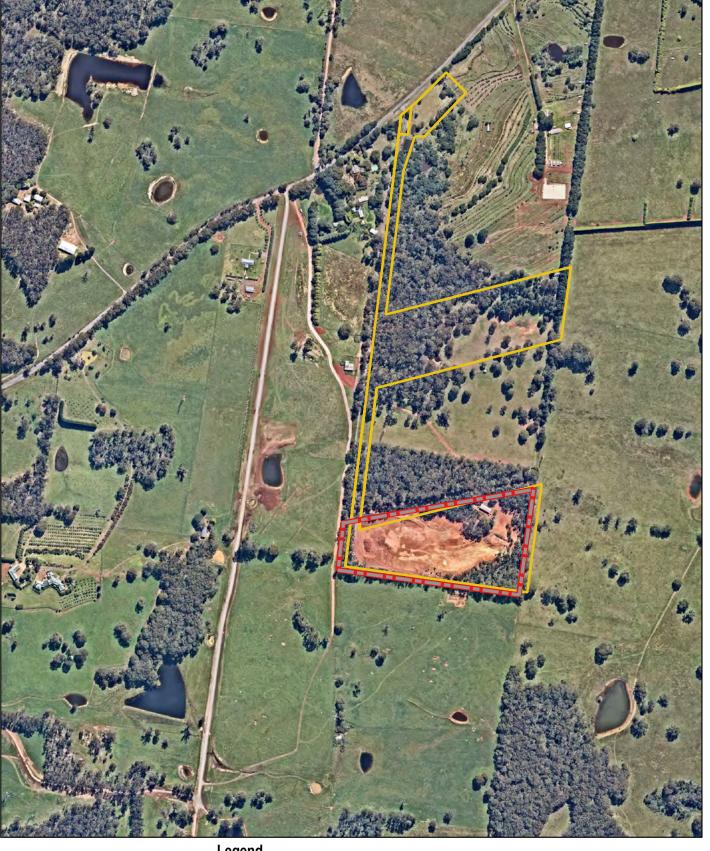
Legend 200 m Authority Boundary (PLL1236) Site Lot boundary Project Approval Boundary

The site is located within the Wingecarribee Shire Council and operates under consent number 08/0326, the conditions of which are included in Appendix A. The property is within land which is zoned Zone C3, "Environmental Management" under the Wingecarribee Local Environmental Plan 2010, see *Figure Two*. Ref 3

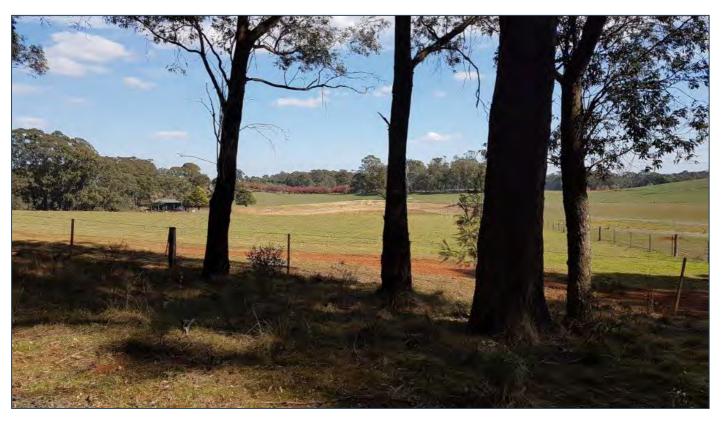
Photoplate 1. Fence

In the interest of public safety and reducing the incidence of trespassers, fences and signage have been maintained along the perimeter of the mine site.
